APPENDIX F – Construction Vibration Monitoring, Manning Street Warwick Farm (July 2009)

Re: Southern Sydney Freight Line - Construction Vibration Monitoring, Manning Street Warwick Farm

Wilkinson Murray has been engaged to conduct vibration monitoring at the construction site adjacent to Warwick Farm Train Station and neighbouring residences in Manning Street, Warwick Farm. The monitoring was in response to an enquiry regarding vibration levels from the operation of a vibratory roller adjacent to a residential/commercial property. This report details results of the monitoring which was conducted between Friday 24th and Thursday 30th July, 2009.

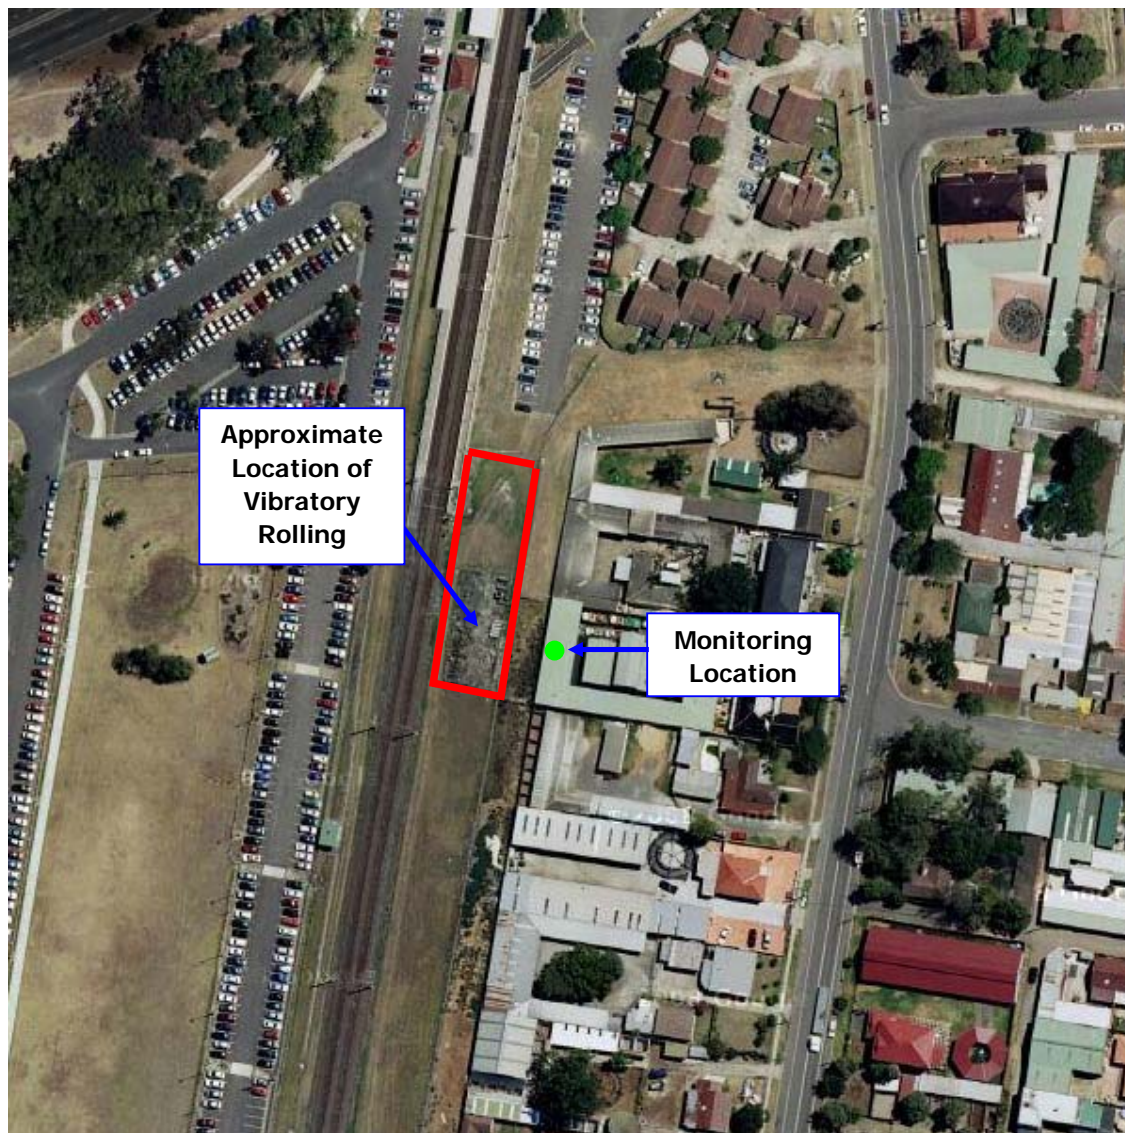
Figure 1 Measurement Locations

Measurements were conducted at 9 Manning Street, Warwick Farm. The measurement location and proximity to works is shown in Figure 1.

A residential dwelling is located at the front of the property, towards Manning Street. At the rear of the property, adjacent to the construction site, are horse stables.

The vibration monitoring was conducted at the rear of the property, in a vacated horse stable.

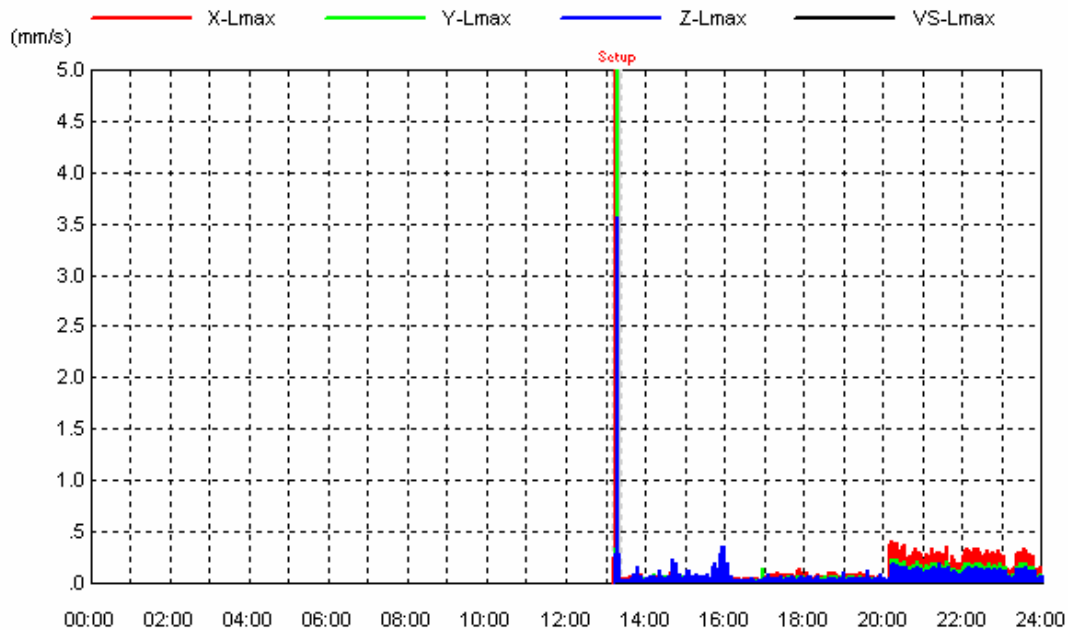
Fri 24 Jul 09

The measured vibration level was typically below 0.5mm/s. During the monitoring period there were several discrete peaks up to 0.8mm/s. These are not consistent with typical vibration producing construction activities such as rock hammering or vibratory rolling which would see an elevated level for a significant duration (minimum 10mins) rather than discretely elevated peaks in one logging period only. These peaks are consistent with short term vibration activity near the sensor, e.g. something being dropped in a neighbouring stable.
