Southern Sydney Freight Line Environmental Protection Licence Monthly Report

August 2009

Document Status	
Project:	ARTC
	Southern Sydney Freight Line
Document:	EPL 12971 Monthly Report – August 2009

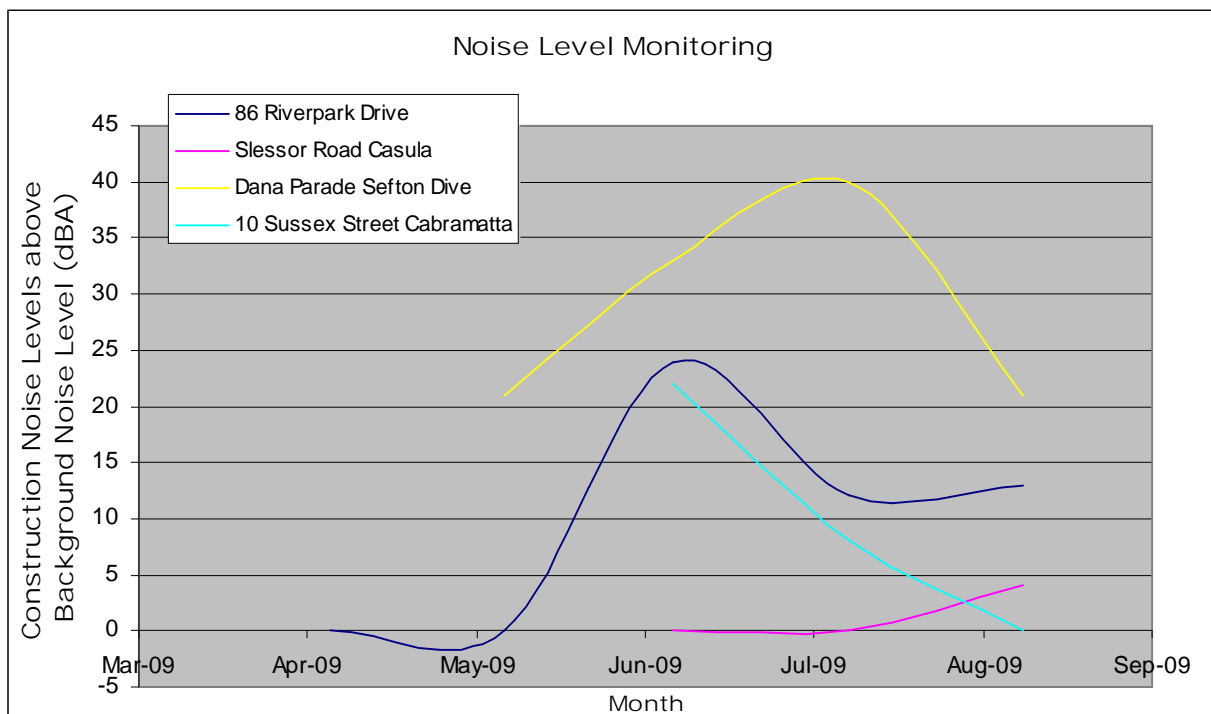
Condition R4.1 (c) of the EPL requires that ARTC provide graphical representations of noise monitoring results obtained over the life the project. Noise monitoring locations vary from month to month. Sufficient data has now been gathered at: 86 Riverpark Drive, Slessor Road Casula, Dana Parade Sefton Dive and 10 Sussex Street Cabramatta for trends to be observed. The results of noise variations at these sites over the last 5 months are displayed graphically below. Appendix A includes a comprehensive list of locations where noise monitoring has been undertaken.

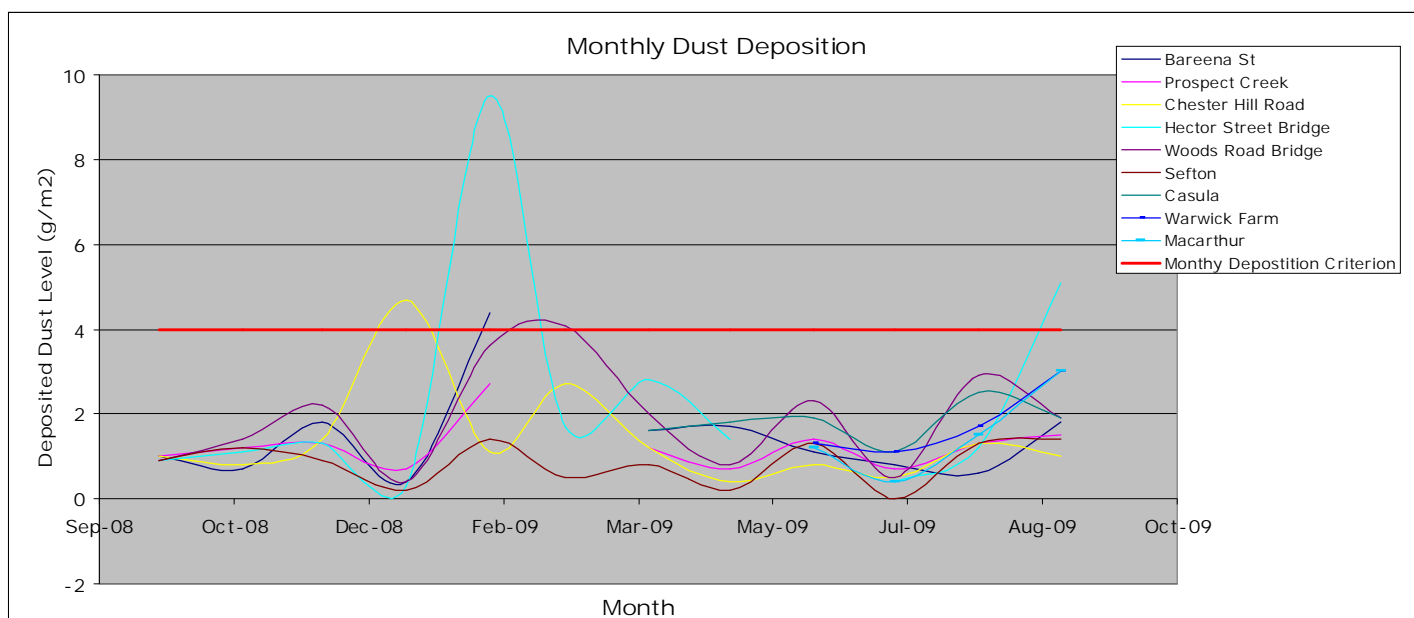
The results show that the level of deposited dust along the length of the SSFL Project, during the month of August was below the maximum total deposited dust level of $4\text{g/m}^2/\text{month}$, stipulated in the DECC's Approved Methods for Modelling and Assessment of Air Pollutants in NSW (2005), at all locations except at the Hector Street Bridge where the dust level was $5.1\text{g/m}^2/\text{month}$.

The elevated reading of $5.1\text{g/m}^2/\text{month}$ at the Hector St site was probably caused by a high level of mechanised activity within the rail corridor in the vicinity of the Hector Street Bridge. Arecco has indicated that there was clearing and grubbing activity at this location as well as stripping of top soil. In this instance, the dust monitor was

positioned below road level and most likely captured dust emitted both from excavation work and substantial truck movements taking excavated material from the site.

In response to the elevated reading Arenco has issued work place inspection report on how to comply with the 4g/m²/month requirement in this area in future. In addition to dust mitigation measures already in place, Arenco is also purchasing 'Terrastop 204', a spun polymer weave to be stretched along 60m of the corridor as an alternative road base. It is anticipated this additional control will minimise dust generated by truck movements.
